**Facilities Task Force  
Meeting 1: October 12, 2015**

## CHIPPEWA FALLS AREA UNIFIED SCHOOL DISTRICT

MASTER FACILITIES PLAN : 2015 - 2030

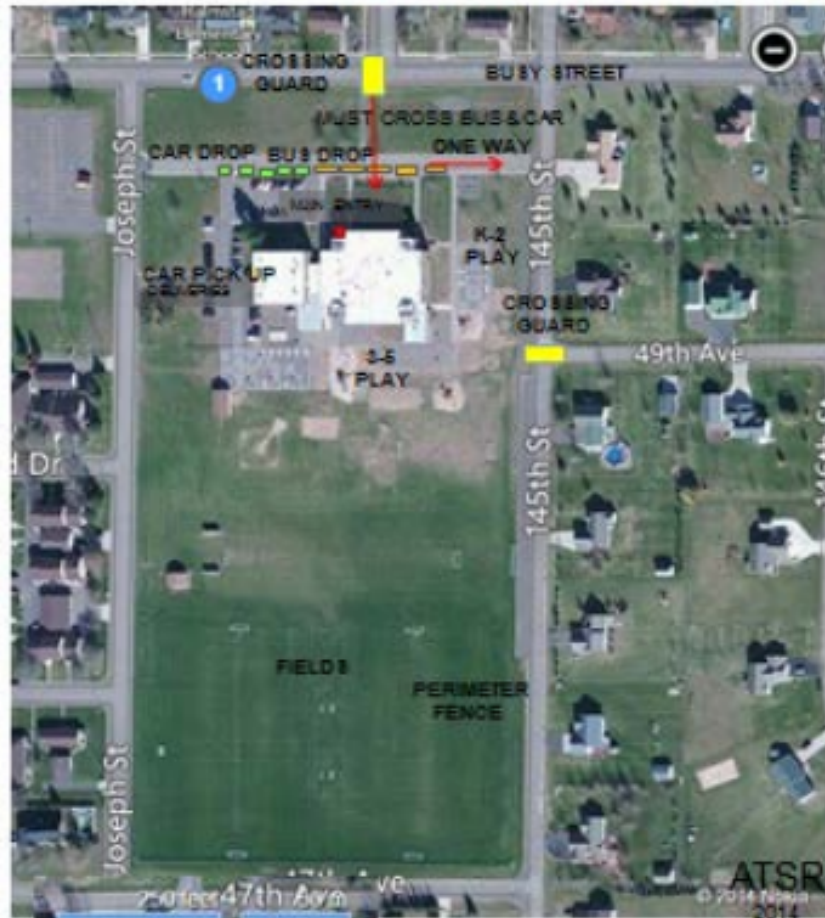
## HALMSTAD ELEMENTARY SCHOOL

Elementary Building Name	2014 Acres	State Standards for SF per Student	State Standards Site Acres per Enrollment	COMMENTS
Halmstad	13.00	150-170	14.3	The Drop off area has good length but does not have proper separation of car drop off and bus drop off. Reorganization is recommended. Site size is adequate but more space needs to be dedicated to the vehicular drop off.
Hillcrest	6.0	150-170	14.5	This site is very very small and 8.5 acres below the State standards for an elementary school and in an urban area which makes it difficult to correct the safety concerns. The car drop off and bus drop off occurs on the public street. There is tremendous pressure at the street area for crossing students, drop off of students and the bus drop off and pick up. The land is limited from the high school and elementary school that occupy this site. The high school site is also under sized compared to State standards. Land acquisition or removal of components on the site should be considered.

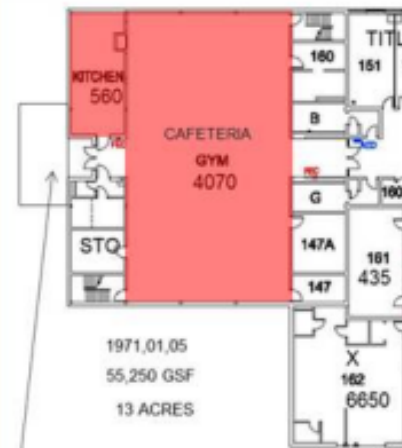
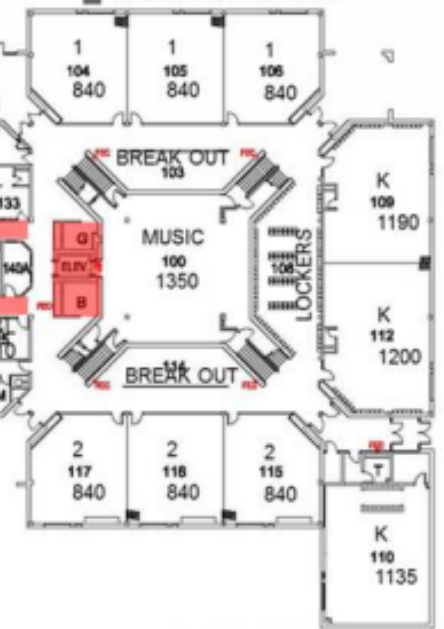
## HALMSTAD ELEMENTARY SCHOOL

- SERVING AND FOOD STORAGE EQUIPMENT STAYS IN GYM
- LIMITED FOOD STORAGE AND PREPARATION AT KITCHEN
- SMALL GYMNASIUM AND CAFETERIA CAFETERIA REDUCES PE CURRICULUM NEEDS AND STUDENTS ARE ONLY ALLOWED 8-12 MIN TO EAT SINCE MUST STAND IN LINE FOR 15 MIN

- PE AND CAFETERIA FILL THIS SPACE 100% OF TIME AND DOES NOT ALLOW USE BY BALANCE OF SCHOOL PROGRAMS
- CANOPY AT GYM ENTRY WOULD HAVE BENEFITS

- LOCKERS ARE LOUD NEAR CLASSROOMS
- K NEEDS BREAK OUT SPACE

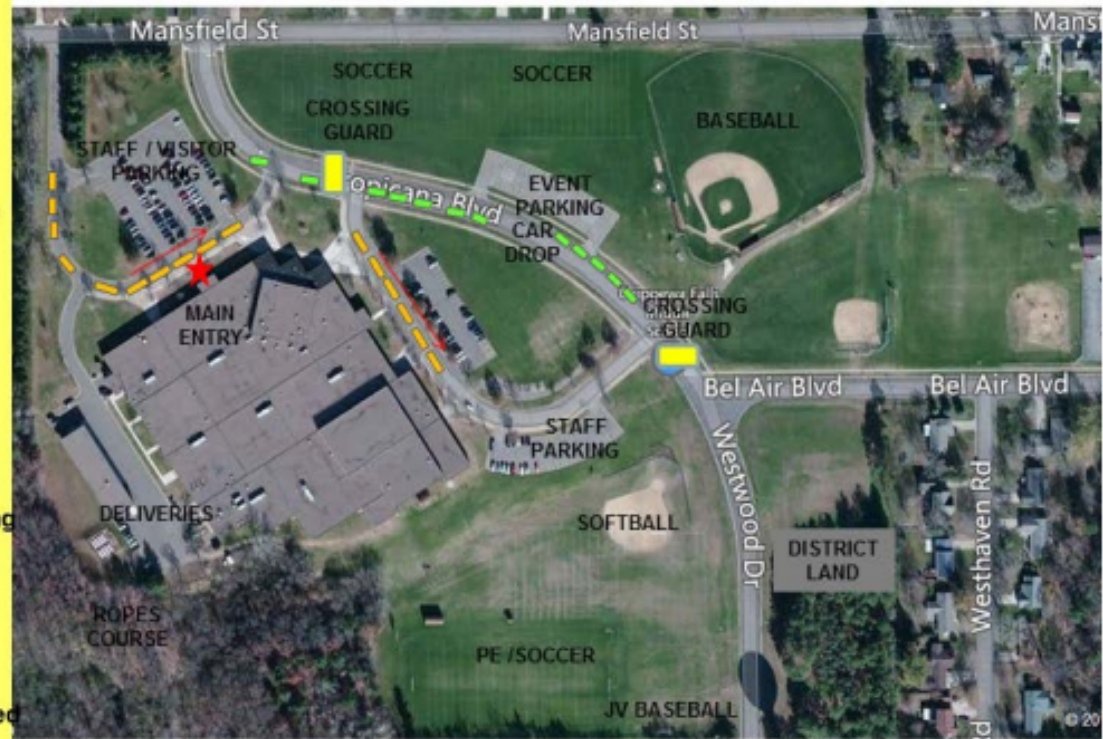
- LACK OF FIELDS FOR PE PROGRAM
- PE SAFETY CONCERN CROSSING ROAD
- FIELDS HAVE HEAVY USE BY ALL AGES IN DISTRICT
- PARKING FOR EVENTS IS SPREAD OUT AND LONG WALK TO ENTRY DOORS

■ IF HAD ROOM WOULD MOVE ALL BUSES TO NORTH AND CAR DROP TO WEST. THIS WOULD CONTROL WALKERS BETTER

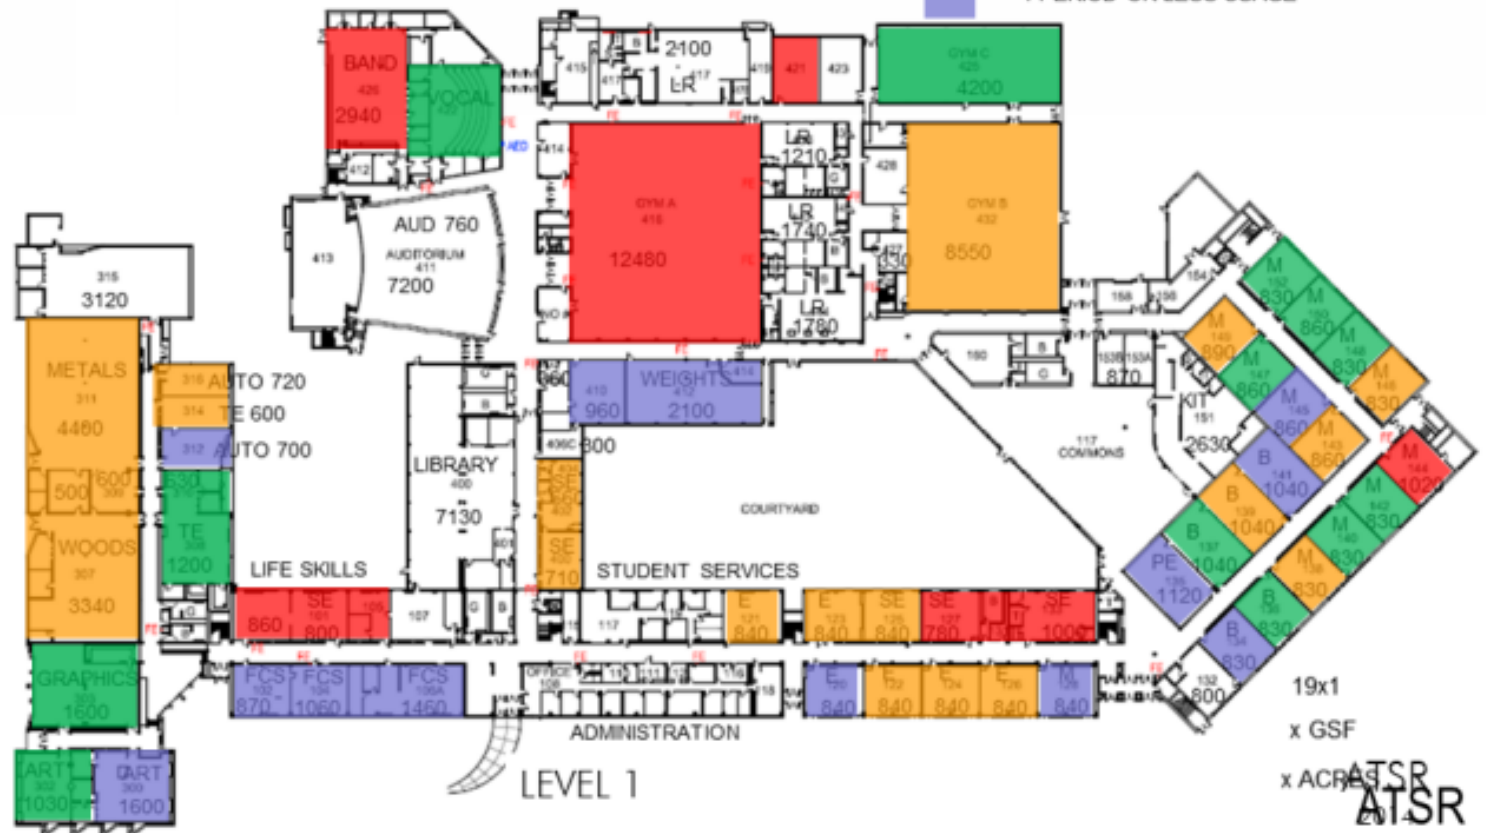
ROOM UTILIZATION PLAN

- 7 PERIOD USAGE OF 7 PERIODS
- 6 PERIOD USAGE
- 5 PERIOD USAGE
- 4 PERIOD OR LESS USAGE

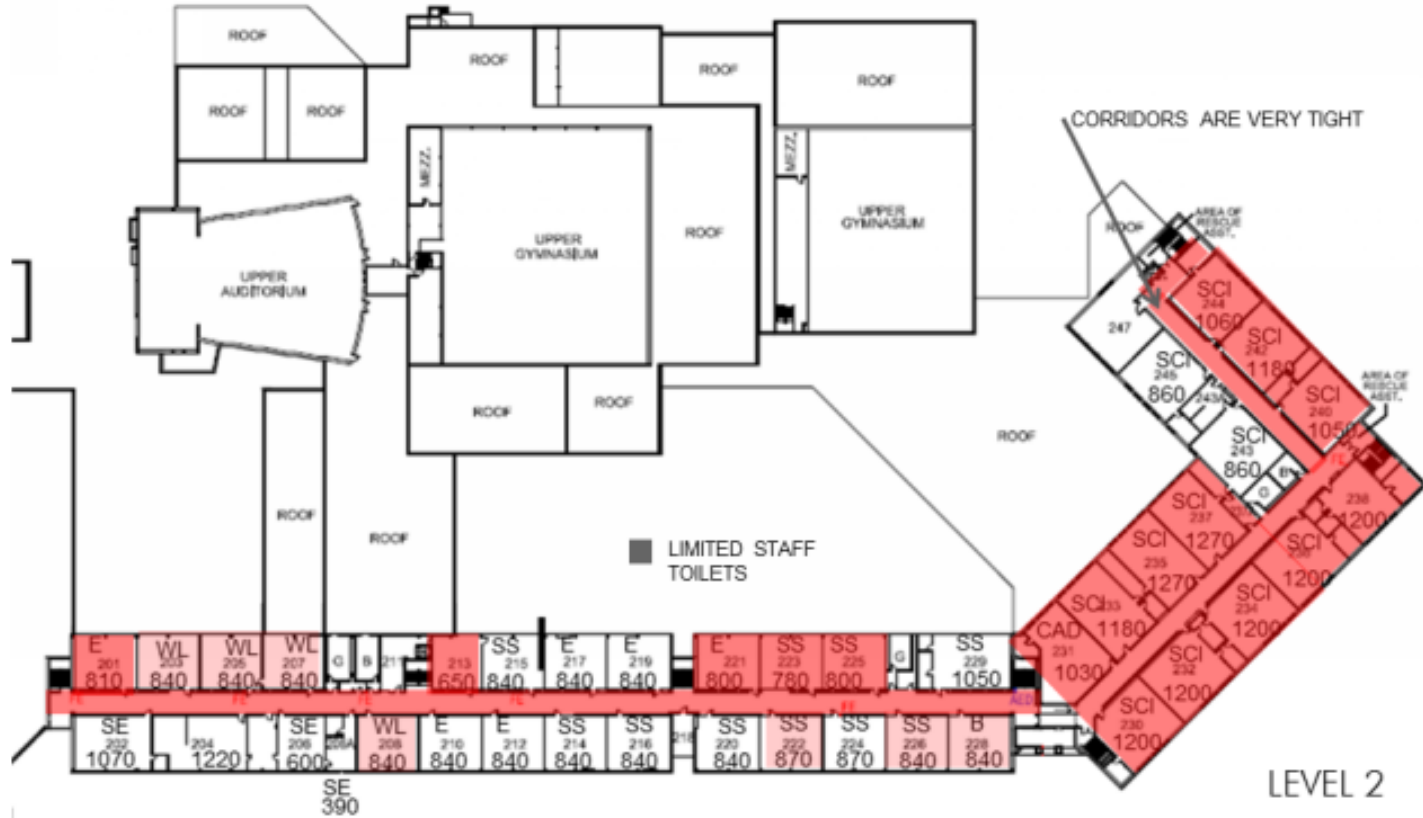
## CHIPPEWA FALLS HIGH SCHOOL

- SPACE DOES NOT EXIST AND IS NEEDED

- NO SMALL & MEDIUM BREAK OUT & CONFERENCE SPACES FOR STUDENT COLLABORATION AND LEARNING
- SCHOOL ORGANIZATION LIMITS IMPLEMENTING "SCHOOL WITHIN A SCHOOL" CONCEPTS
