CHIPPEWA FALLS AREA UNIFIED SCHOOL DISTRICT

2021 FACILITY STUDY & MASTER PLAN

03.09.22

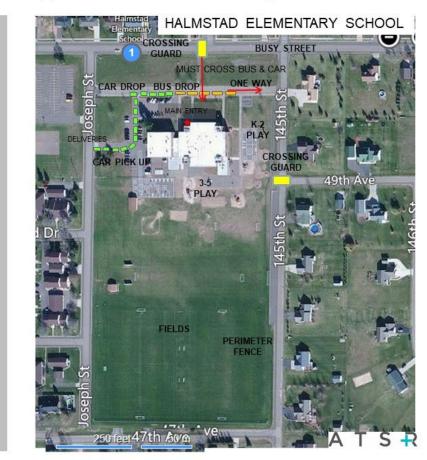
From the aerial view of the site, as shown above, and based upon interviews of faculty, staff, and administration, the following deficiencies are noted:

- The designated bus drop off area and parent drop off/pick up areas are within the same vicinity creating congestion and posing a safety hazard to students.
- The 2015 SRTS plan noted that restriping at crosswalks and additional crosswalks will improve safety
- The 2015 SRTS Plan noted discontinuous sidewalk pathways to school.
- The 2015 SRTS Plan noted no school zone signs present and vehicle traffic is fast on all streets adjacent to the school campus. This is especially important at Halmstad because it has one of the highest percentages of students walking, biking, or taking bus home from school.

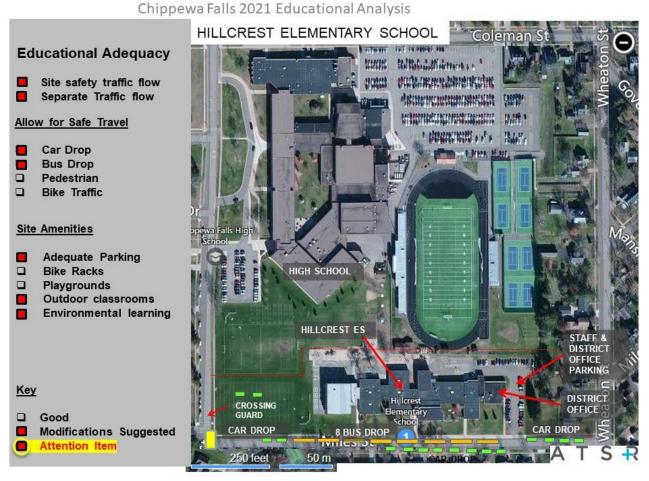
Site Analysis:

As shown in the aerial view of the school above, this site is relatively small. Play area was recently updated with new equipment and green space. Also noted in the aerial photo is the congestion around the student/parent drop off and pick up areas when buses are loading and unloading. The west end of the site is often used for High School practice.

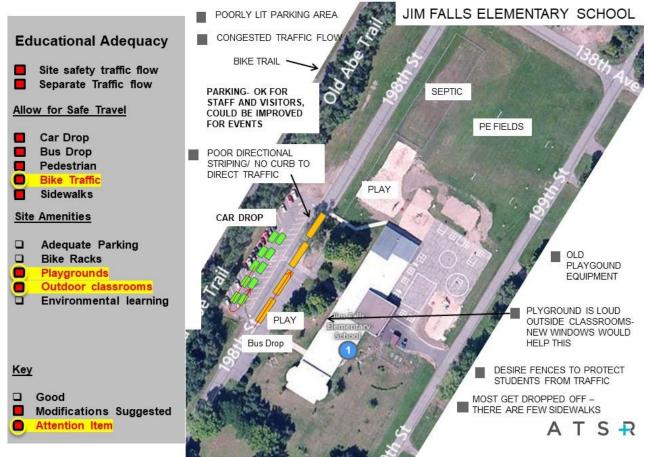
From the aerial view of the site, as shown above, and based upon interviews of faculty, staff, and administration, the following deficiencies are noted:

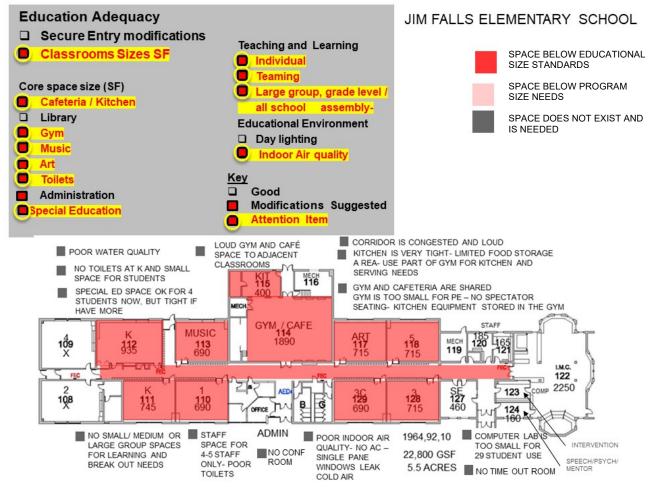
The footprint and anecdotal comments above articulate some of the 'short-comings' found in a review of how the building is being used. The majority of the classrooms are undersized and additional classrooms and breakout spaces are needed to meet enrollment needs. The restroom facilities are small. The aging air ventilation system (as noted in the Facility Analysis above) creates a less than ideal learning environment for both students and staff. The corridors are congested during passing time and there is little room available for

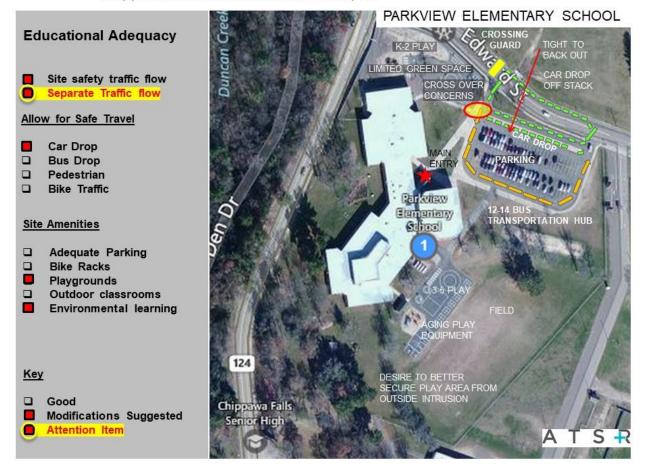
From the aerial view of the site, as shown above, and based upon interviews of faculty, staff, and administration, the following deficiencies are noted:

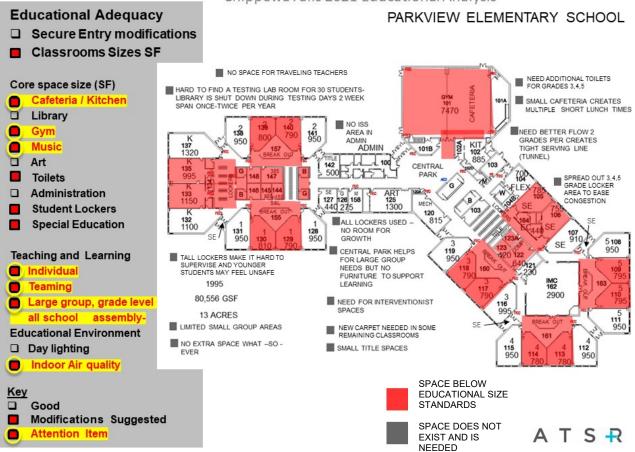
The footprint of the school below shows some of the deficiencies cited based upon an analysis of how the building is being used, interviews with faculty and staff and conducting a comparison of classroom size to established recommended standards.

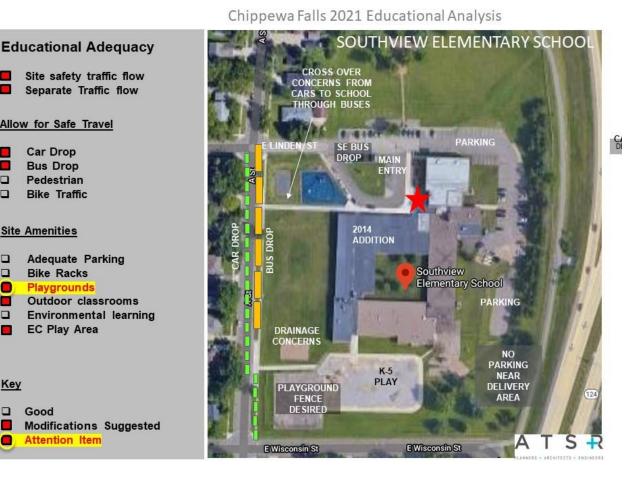
From the aerial view of the site, as shown above, and based upon interviews of faculty, staff, and administration, the following deficiencies are noted:

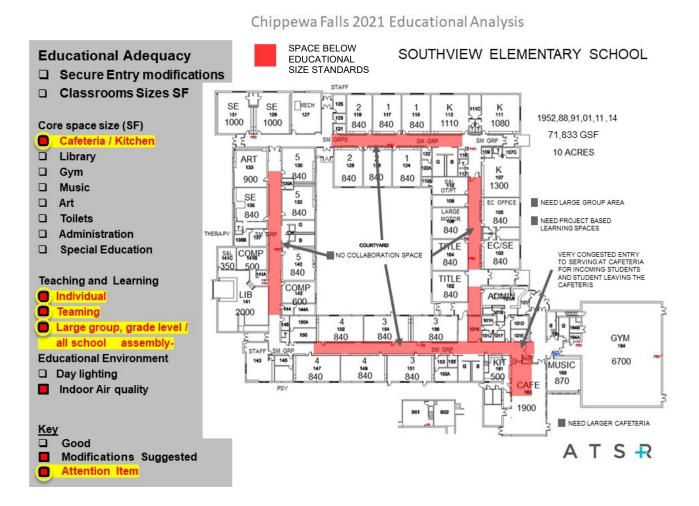
As shown in the diagram of the footprint and anecdotal comments above, generally this school has few deficiencies.

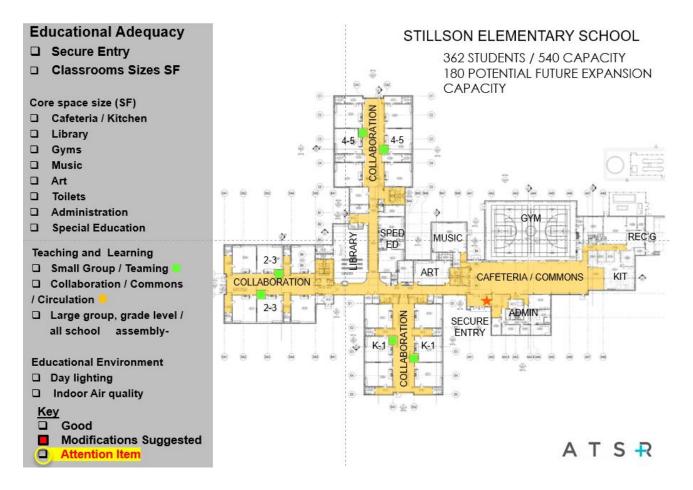
The illustration of the building footprint below highlights the small group/teaming areas evenly distributed between houses, as well as collaboration and common spaces. Special Education and learning media center are located at the core of these houses The primary area of concern is the overall size of classrooms.

There are currently no known educational deficiencies. Given the short amount of time that students and staff have occupied the building at the time that user feedback was received for this study, no user feedback has been received.

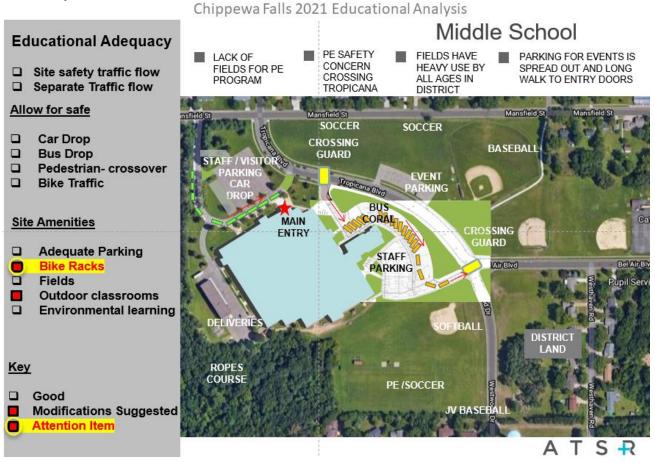
Site Analysis:

From the aerial view of the site, as shown above, and based upon interviews of faculty, staff, and administration, the following deficiencies are noted:

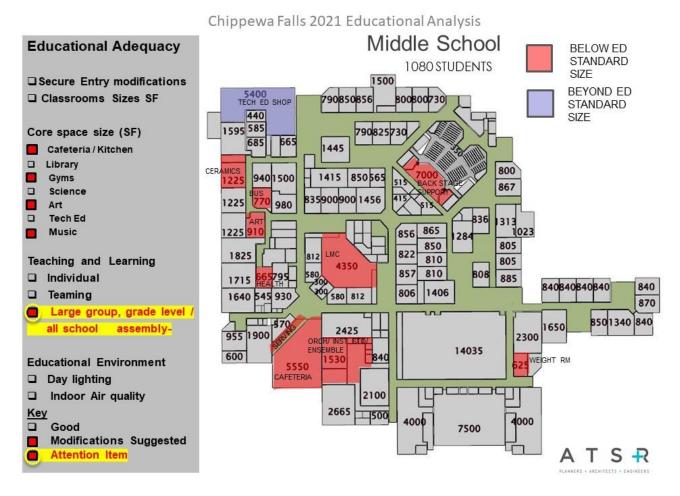
The illustration of the middle school footprint and anecdotal comments shown above highlight some of the concerns raised through a careful analysis of how the building is utilized throughout the day.

The school lunchroom, serving area and preparation areas are too small to serve the number of students required by the schedule currently in use and must instead go to three periods. The auditorium stage is small

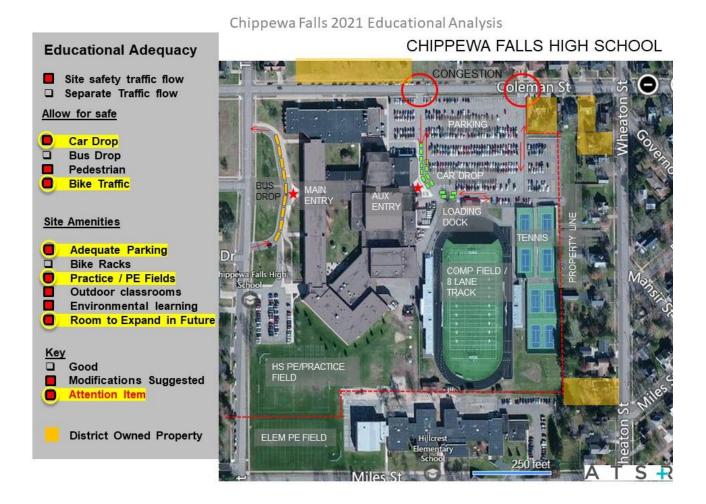
Site Analysis:

From the aerial view of the site, as shown above, and based upon interviews of faculty, staff, and administration, the following can be noted:

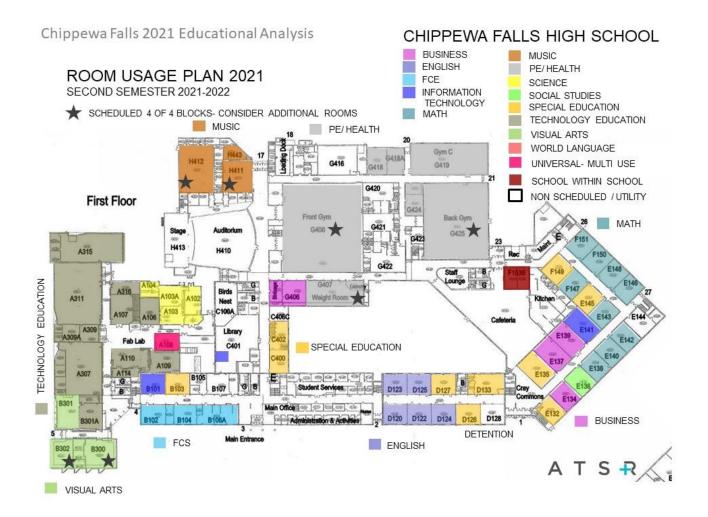
The illustration below is an analysis of room utilization throughout the school day. It suggests that in curricular areas such as physical education, music, and life skills- rooms are scheduled virtually throughout the entire school day. The majority of classrooms are scheduled at least five (5) periods out of the seven (7) period day. The building is scheduled very efficiently, which limits future growth and program variations.

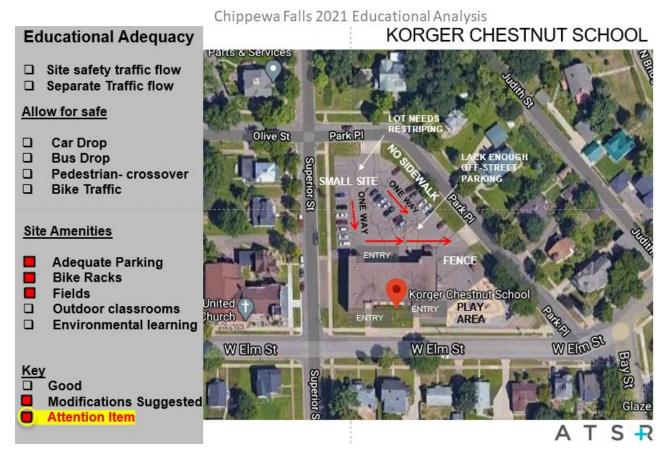
Site Analysis:

From the aerial view of the site, as shown above, and based upon interviews of faculty, staff, and administration, the following can be noted:

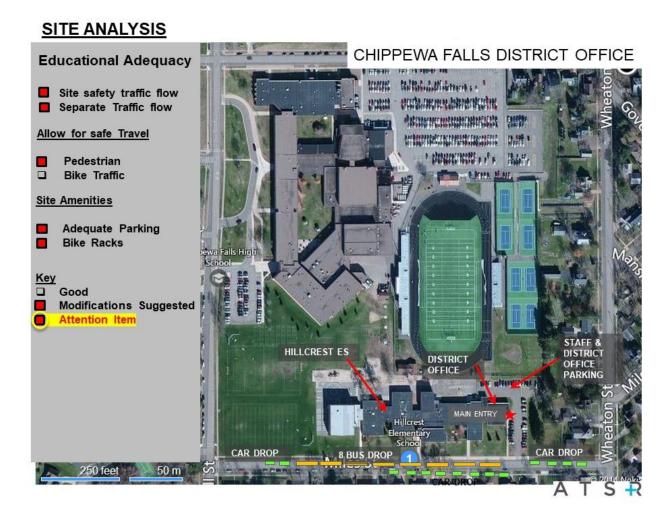
From the aerial view of the site, as shown above, and based upon interviews of faculty, staff, and administration, the following can be noted:

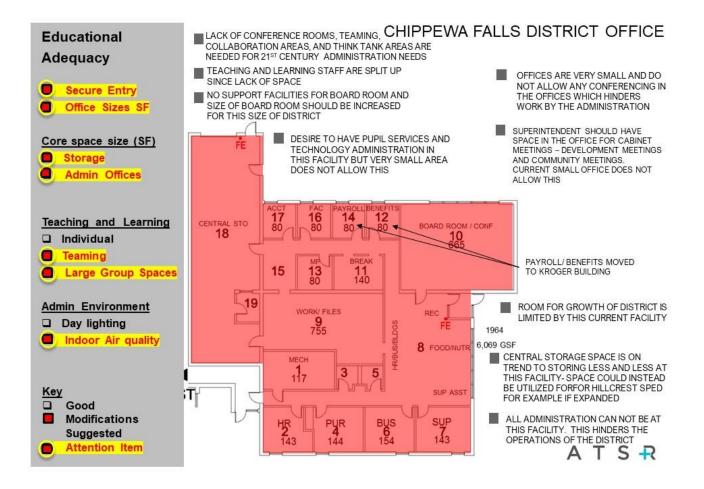
The District Office is currently not being used for educational programing in any capacity. The illustration of the building footprint below defines its use. Anecdotal comments citing some of the existing functional deficiencies are noted. The staff/visitor toilets do not meet current accessible codes.

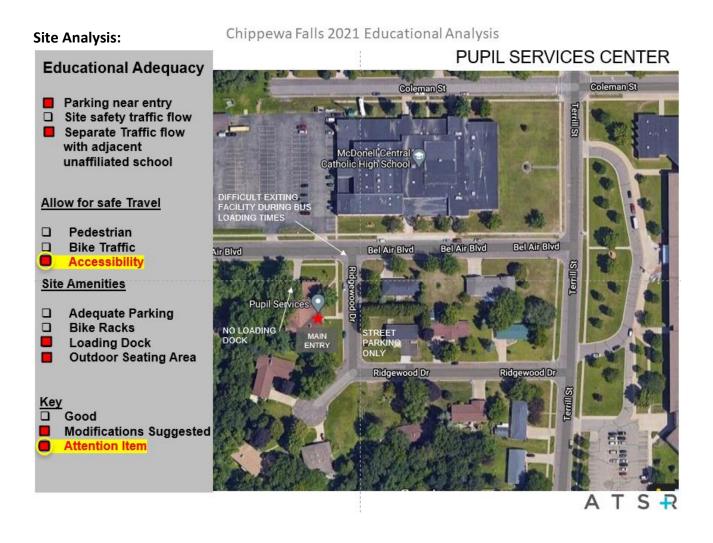
From the aerial view of the site, as shown above, and based upon interviews of faculty, staff, and administration, the following can be noted:

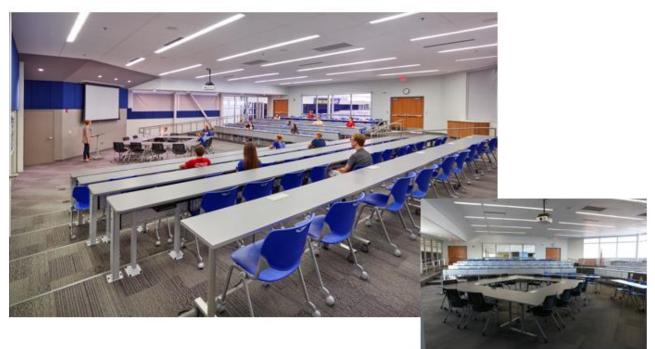
LARGE GROUP SPACE

CONSIDER ADDING A "FORUM" ROOM TO THE SCHOOL. A PLACE FOR 150-250 STUDENTS TO GATHER AND SHARE IDEAS – LISTEN TO A PRESENTATION OR FOR TESTING. THIS BECOMES A MAIN USED SPACE IN THE SCHOOL FOR MANY BEFORE – DURING AND AFTER SCHOOL EVENTS

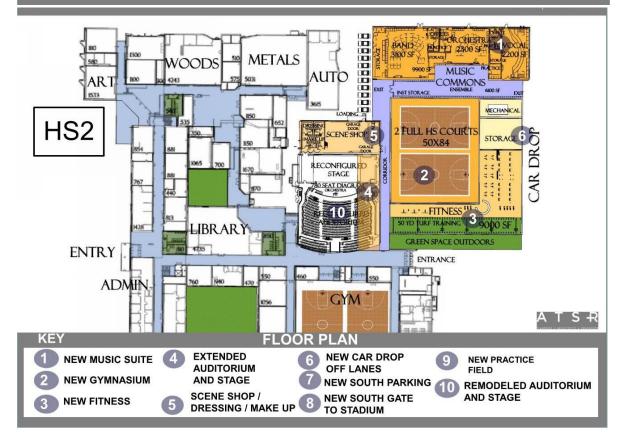
- 4. Refresh the existing Auditorium house with new seats, flooring, ceiling acoustic reflectors, theatrical lighting, house lightning, sound system, theatrical lighting controls, new side wall box boom locations and side wall upper coves and general ambiance.

- 5. Added support spaces to enhance the stage function. A new scene shop, dressing rooms, make up space, storage and back stage circulation.
- 6. Site Improvements include improved and enlarged North side car drop off.New parking is added at the south parking lot area to replace the parking lost from the gym and music addition.

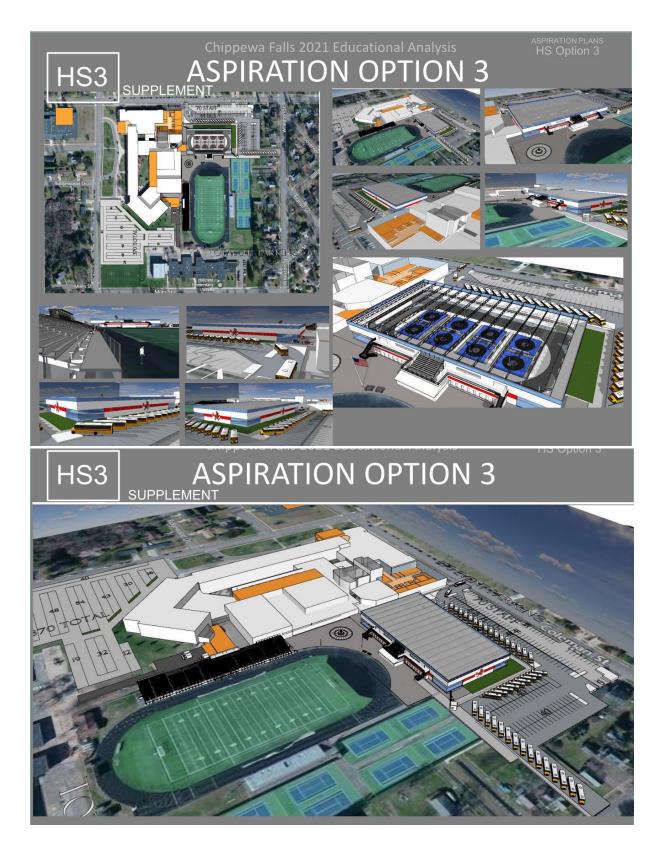
ASPIRATION OPTION 3

Option 3 High School – Field House Study Input suggested the need for a field house at the high school. This is a field house study for the high school property. Other options can be added to this option if desired.
